NATIONAL PROGRAM FOR INSPECTION OF NON-FEDERAL DAMS  
OLIVERIAN DAM (NH-002) (U) CORPS OF ENGINEERS WALTHAM  
MA NEW ENGLAND DIV MAY 79

OLIVERIAN DAM

NH-00268

PHASE I INSPECTION REPORT  
NATIONAL DAM INSPECTION PROGRAM

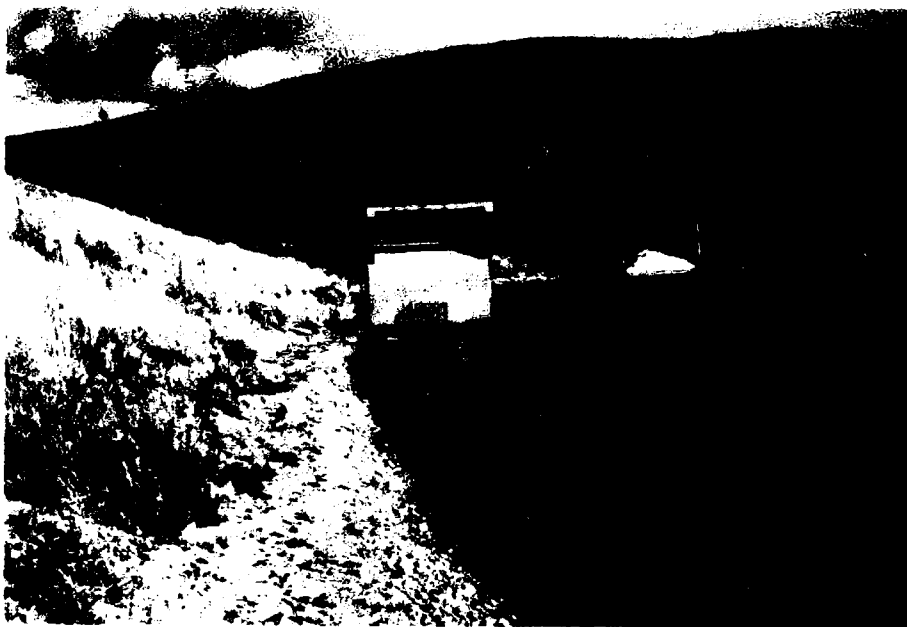
3

CONCRETE RISER SECTION OF PRINCIPAL SPILLWAY;  
EMERGENCY SPILLWAY IN BACKGROUND
